## CMU 3 - WEST- FACING SLOPE

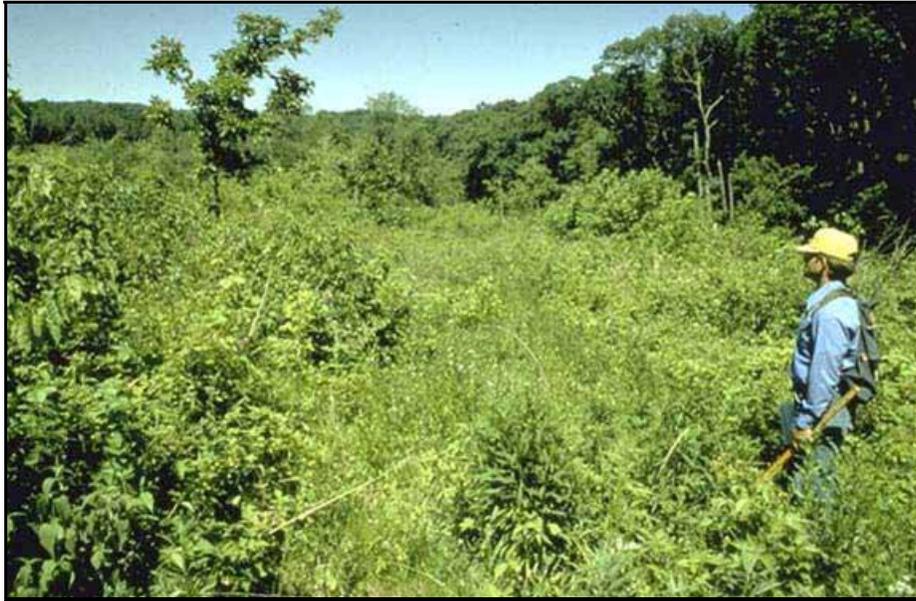
The inventory of this unit revealed that the forest stand has been cut-over and high-graded. The owners say that this harvest took place five years ago. All merchantable conifers and hardwoods were removed at that time. The site is now occupied with undesirable herbaceous, shrub, and hardwood tree species. The Firs want to plant Conifer 2 on this unit to restore a productive, wood-producing condition as soon as possible for purposes of income later on and/or inheritance by grandchildren.

Access to the field is through a field road which begins at the county road along the west boundary of Field 3 and ends shortly after entering the field on the west side. Skid trails fork off the field road to allow access for harvest operations. The roads and skid trails have numerous excessive erosion areas. The planner noted 7 log landings scattered throughout the field. These decks are also showing evidence of sheet and rill erosion along with some gully erosion. The landings are currently not vegetated.
