Planning Unit – (Module 3)

Planning Unit = 220 ac.

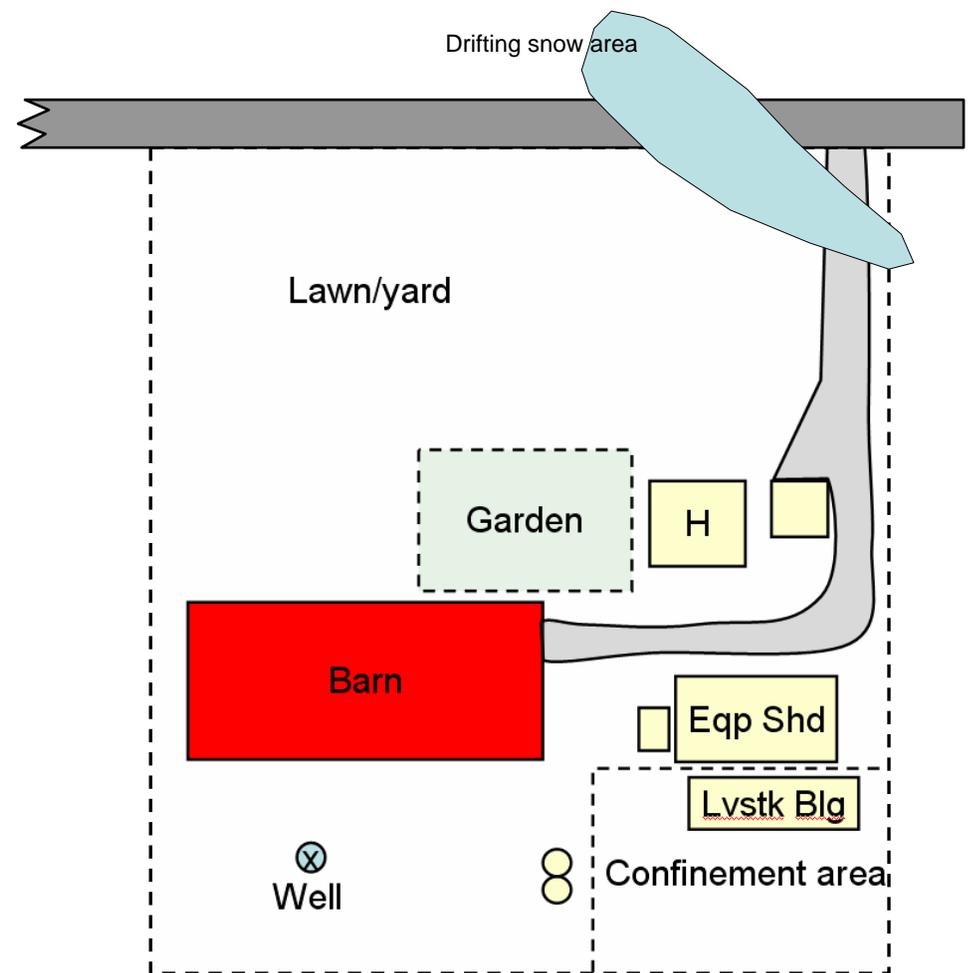
CMU HQ - Headquarters

- The unit consists of a house, garage and shop, well, a small barn for hay and silos for grain storage, and a yard and garden. There is a small confined feeding/holding area for beef cattle. Deer frequently damage the few ornamental trees and shrubs around the house. Dust from nearby cropland is common in the spring. During the winter, drifting snow on the county road and driveway and near the house cause access problems. High winter heating bills are common.

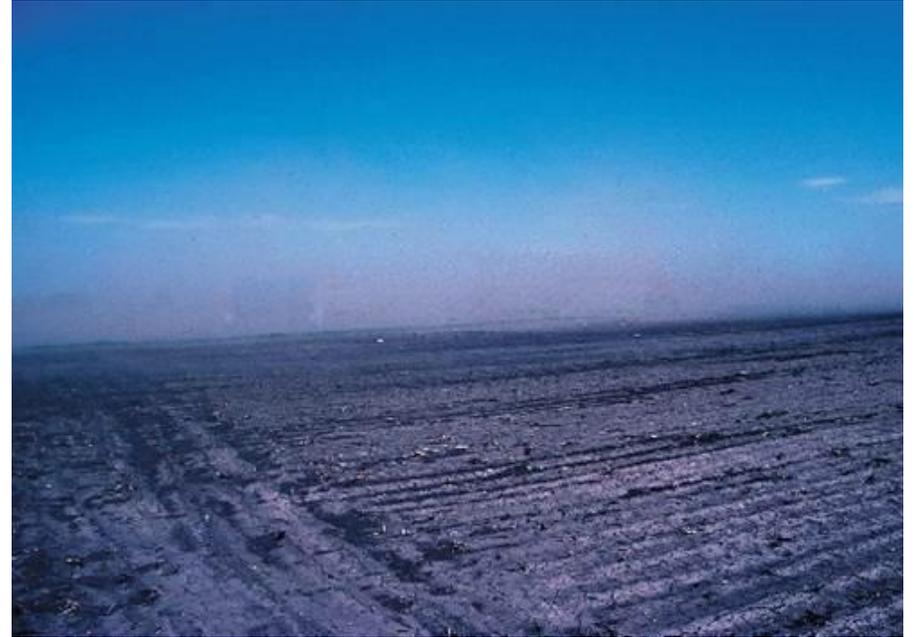
CMU 1a - Crop

- **Crop seedling establishment (annual crops) is impaired by unsheltered winds from the northwest. Soil is being deposited along the east edge of the field. The Alpha soil is the predominate soil type with slopes that range from 0-2%. No permanent cover is present. Limited fall hunting opportunities. Wind erosion in the field was 10 tons/acre/year. The habitat evaluation worksheet for the crop field resulted in a score of 0.2 for wildlife habitat.**

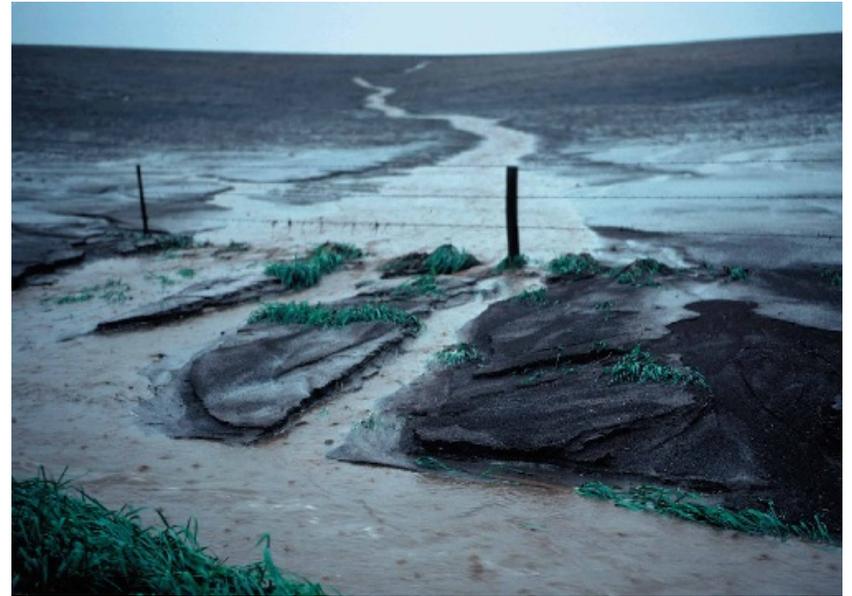
CMU 1b - Crop

- The Beta soil is the predominate soil type with slopes that range from 3-8%. Cropland soil erosion has created soil deposition along the east fence line. An ephemeral gully was observed at the south end of the unit. No permanent cover is present.

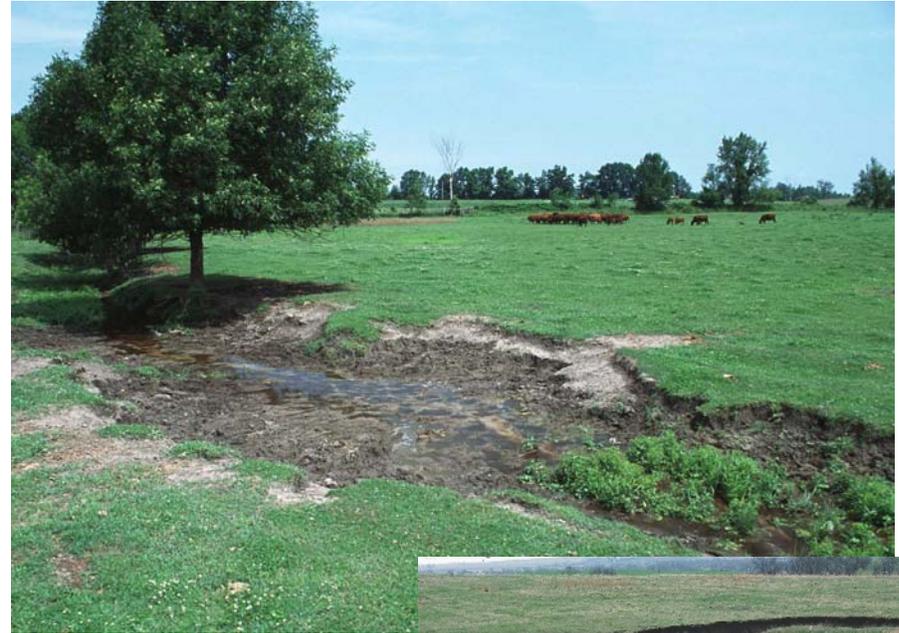
CMU 2a - Pasture

- Livestock grazing is alternated between the pasture unit (2a) and the naturalized/grazed forest units (2b, 2c). Livestock are confined during the winter and early spring. Livestock are causing stream bank trampling at the south end of the pasture unit and damage to the spring area. Slopes range from 2-8% on soil types Alpha and Beta. Upland bird species were noted along the south end edges of the unit.

Above: Condition of upper intermittent stream.

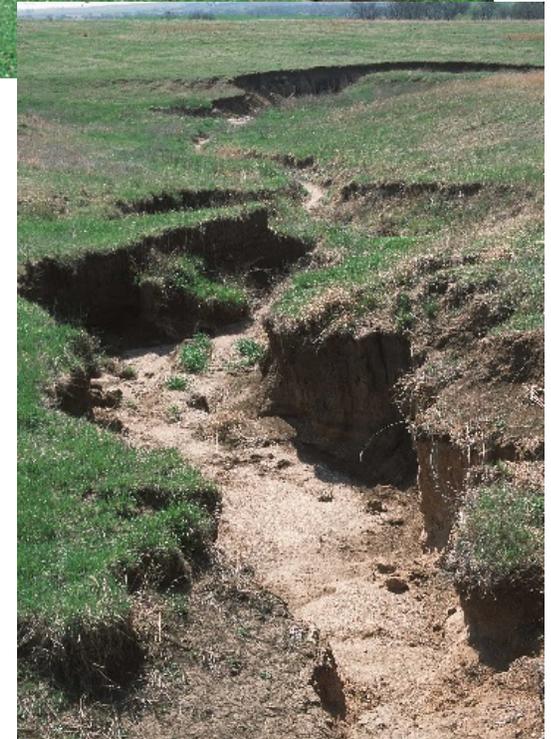
Right: Condition of lower intermittent stream just above the confluence with the spring-fed reach.

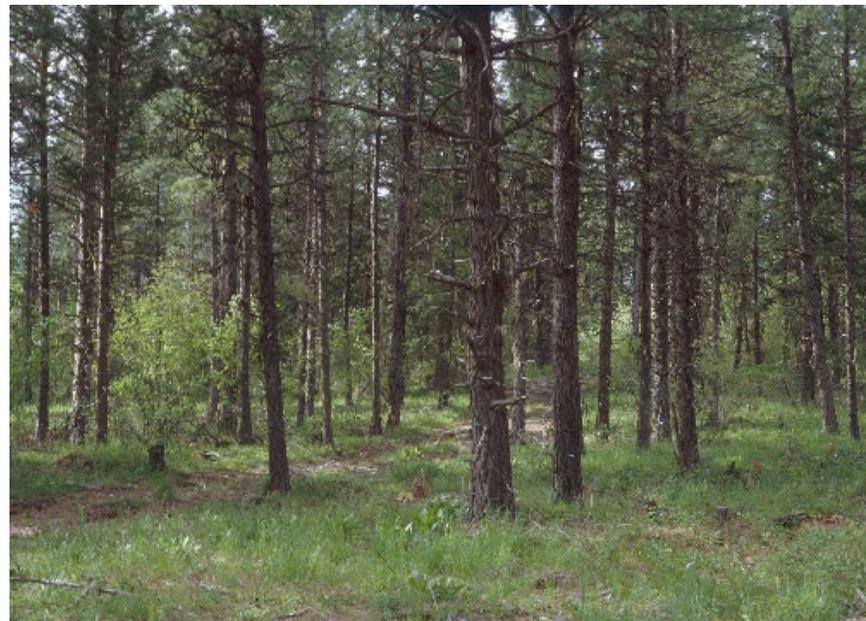
CMU 2c – Grazed Forest

- The Beta soil predominates on the unit with slopes ranging from 8-15%. Unrestricted livestock access throughout the entire unit.
- A naturally-established, even-aged stand of conifers occupy the northern area of the unit and range from 12-18" diameters-at-breast-height (DBH). There are scattered openings of herbaceous vegetation/forage; canopy shading has reduced forage production under the trees. Snags are scattered throughout the area.
- The south end consists of upland mixed "high quality" hardwoods adjacent to the spring-fed stream with slopes ranging from 15-25%. The hardwoods range from 6-14" DBH and are uneven-aged mast-producing trees. The area has evidence of livestock trampling and compaction including the stream area. Also, tree regeneration and understory vegetation densities are low. Lower than optimum wildlife numbers are also present.

View from road at the northern tip of unit looking south.

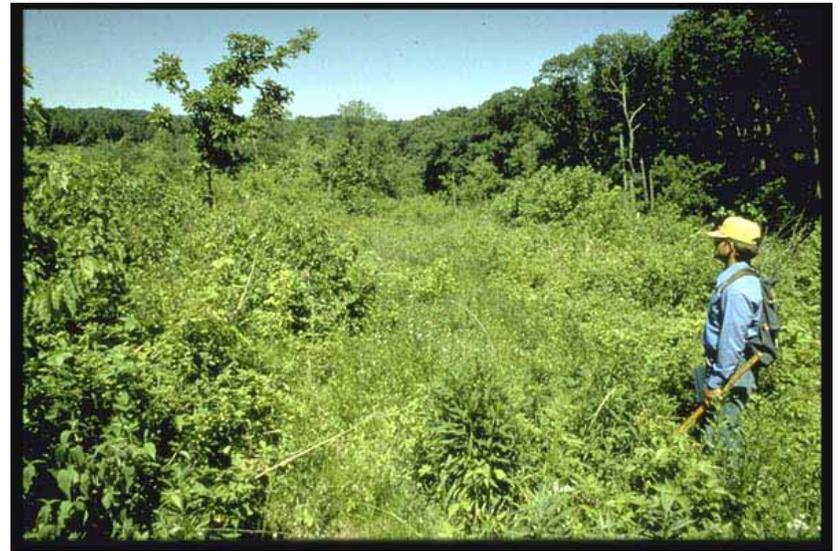
CMU 3 – Forest

- **Shade-intolerant 4-8” dbh conifers occupy east facing steep slopes (25-40%). The area has extensive mortality from bark beetles and tree competition creating slash and debris that pose a significant wildfire risk. “High-graded” bottomland hardwoods occupy 0-2% along Noname Creek. The stream crossing consists of an old, undersized culvert that has been damaged by flooding and is acting as a barrier to fish movement. Tree removal from riparian areas has reduced shade and increased stream water temperatures. Stream banks are eroding in several spots. These conditions have decreased suitable trout habitat and populations have declined. East and upslope of Noname creek, the slopes range from 10-20%. All merchantable conifers and hardwoods were harvested 5 years ago. The site is now occupied with herbaceous, shrub and undesirable hardwood tree species. Roads and skid trails have numerous areas of excessive erosion partially caused by trespass of 4WD vehicles.**

East and upslope of Noname Creek.
