Planning Unit – (Module 3)

Planning Unit = 220 ac.

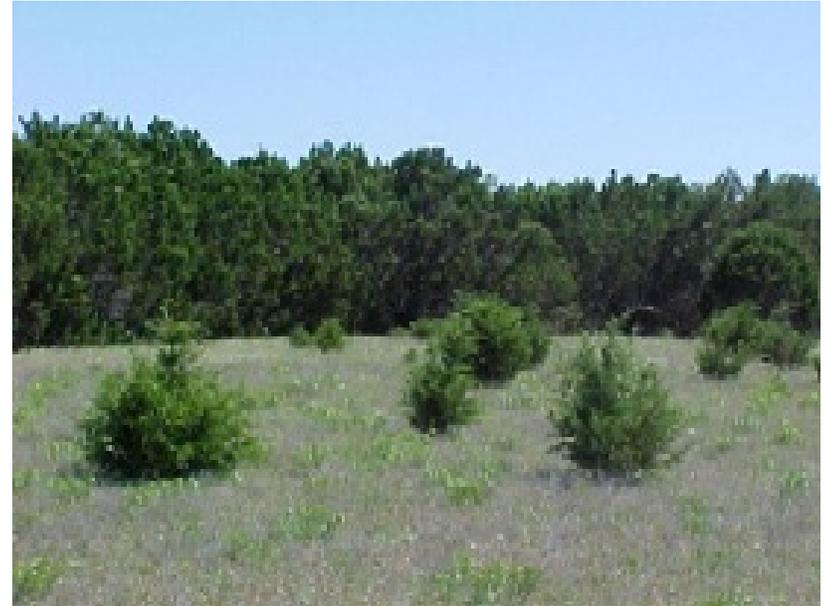
CMU 2c – Grazed Forest

- The Beta soil predominates on the unit with slopes ranging from 8-15%. Unrestricted livestock access throughout the entire unit.
- A naturally-established, even-aged stand of conifers occupy the northern area of the unit and range from 12-18" diameters-at-breast-height (DBH). There are scattered openings of herbaceous vegetation/forage; canopy shading has reduced forage production under the trees. Snags are scattered throughout the area.
- The south end consists of upland mixed "high quality" hardwoods adjacent to the spring-fed stream with slopes ranging from 15-25%. The hardwoods range from 6-14" DBH and are uneven-aged mast-producing trees. The area has evidence of livestock trampling and compaction including the stream area. Also, tree regeneration and understory vegetation densities are low. Lower than optimum wildlife numbers are also present.
